ALARM 5136 # OF AMPS IS SMALL ON i SERIES CONTROL

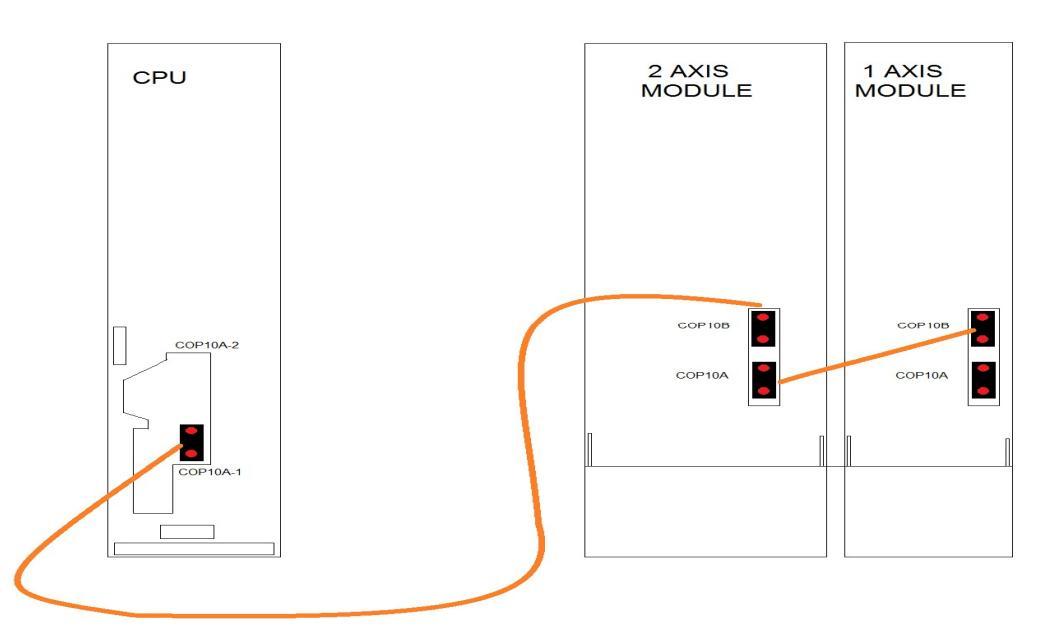
For a new install, make sure that the fiber optic cable runs from the axis PCB on the control to COP10B of the first servo module. Then, make sure the fiber optic cable runs from COP10A of the first servo module to COP10B port of the next servo module in line. Continue this pattern for all remaining servo modules being used.

This can be caused by bad servo module, bad fiber optic cable, or bad servo module in the control. To test the servo modules, change parameter 9900 to the lowest number possible. If you have single axis drives, that would be a one - dual axis drives, the number would be two - three axis drives, the number would be three. Next, move the fiber optic cable that runs from COP10A on the axis module to the COP10B port of the drive being tested. The control will only look for the number of axis that is entered into parameter 9900. Hopefully you can then test the servo modules one at a time to see which is generating the alarm. If all drives generate the alarm then check fiber optic cable and axis PCB in the control.
